Salt Pans, Brora Back Beach, Clyne, Sutherland

**Coastal Erosion Monitoring Diary
October and November 2004**

Clyne Heritage Society/Shorewatch

Coastal Erosion Monitoring Diary – October and November 2004

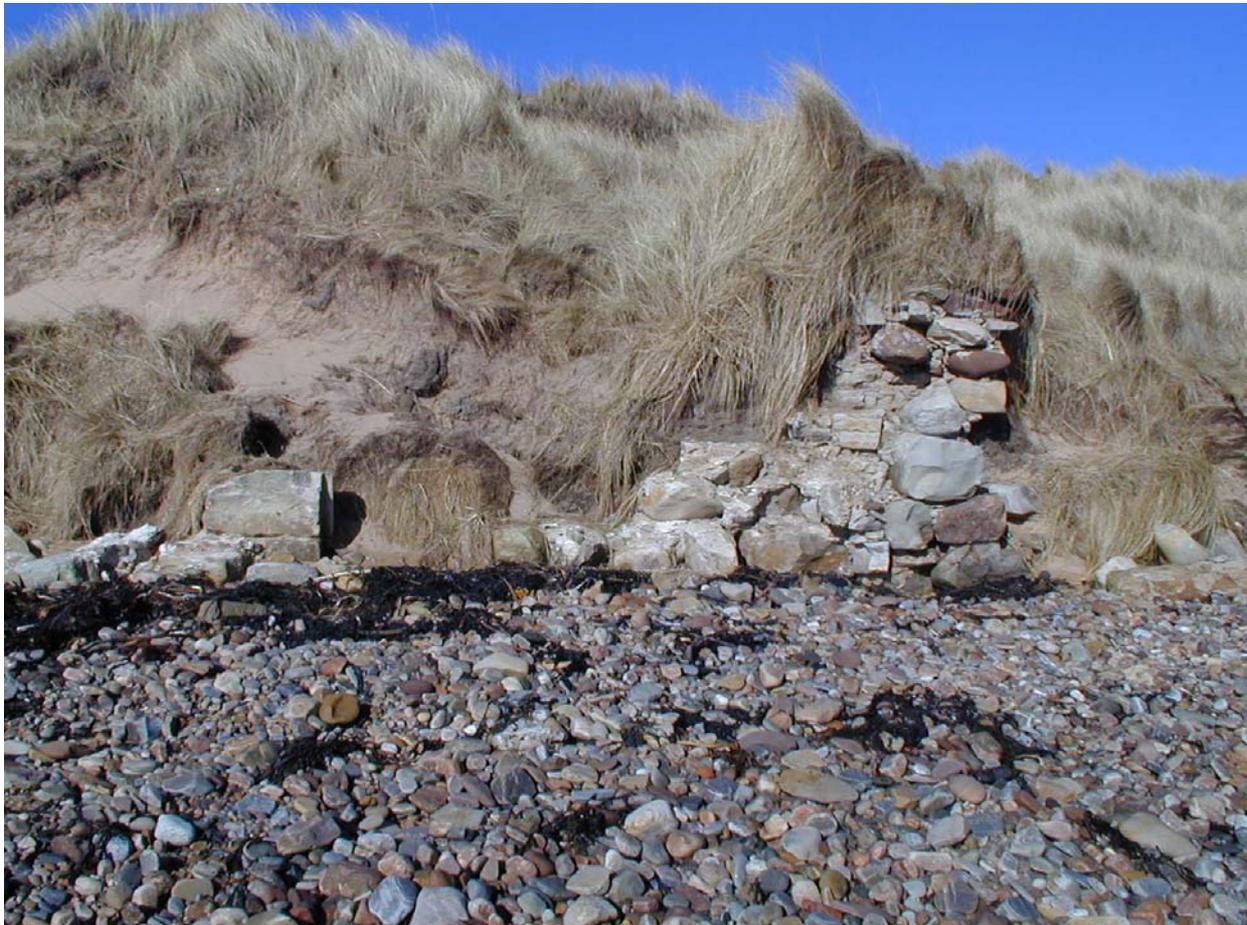
It was observed that the force of the tide had completely removed a sand and stone bank that had been protecting the eroding wall that was surveyed in June 2004 (figure 1). The built up bank was situated about 1-2m in front of the eroding wall and had provided an effective barrier against the tides in the recent past. The bank was quite stable in June 2004 but has now been washed away with the autumn high tides and storms. It is estimated that over 1m of cover has been removed from the area in front of the wall and photographic evidence has aided this judgement. The loss of sediment from this part of the beach has helped to reveal much more collapsed building material. It is very difficult to make sense of the mixture of stones and it is possible that traces of other old walls may be identified in the rubble on the beach.

Figure 1 - Protective stone and sand bank in front of eroding wall, October 2003

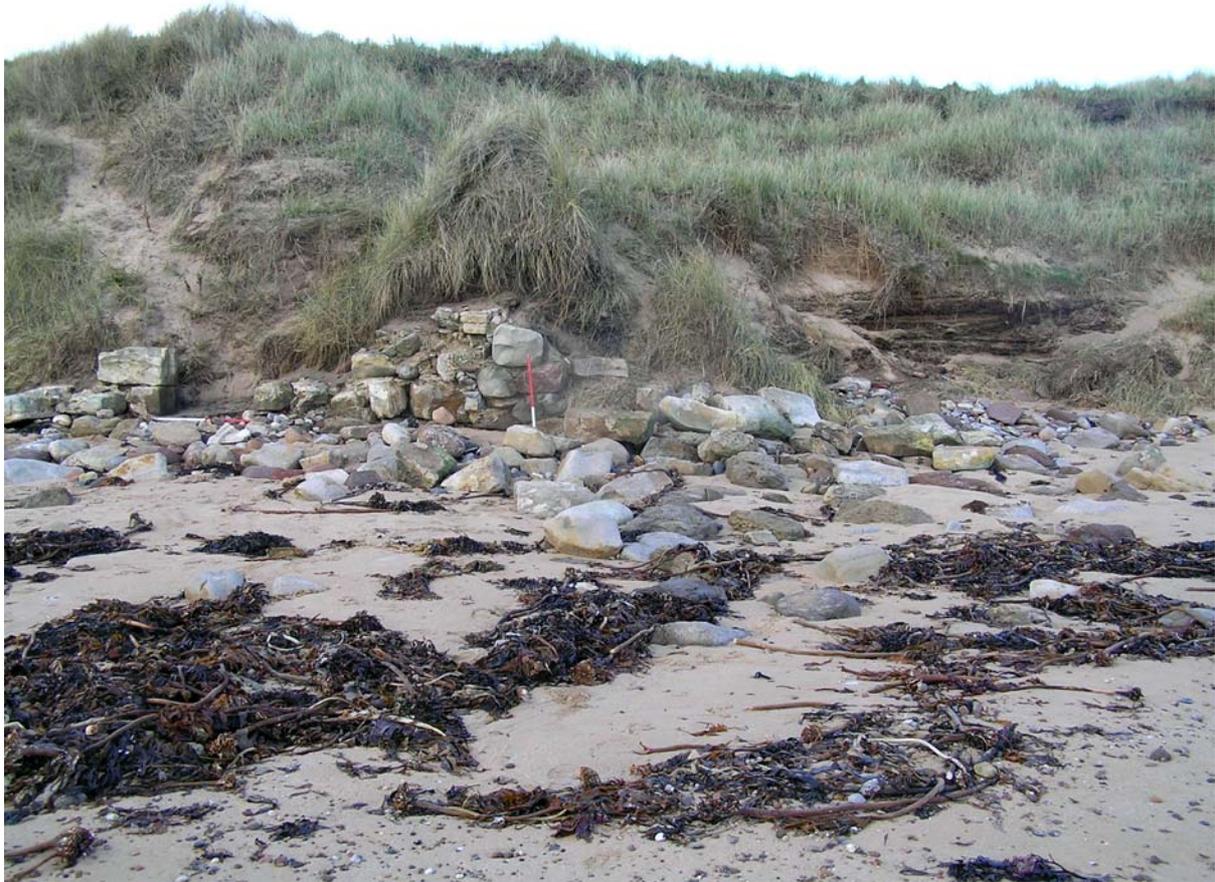
Now that the protective cover has been removed there is no barrier to prevent the tides from gaining access to the very fabric of the wall and causing further erosion. It was noted that the tide was lapping the wall itself and the sand dunes.

Figure 2 - A photograph taken a year later (October 2004) shows that the protective bank has been washed away and part of the upstanding wall has collapsed

The force of the sea had caused some parts of the wall to break apart and become dislodged from the foundation stones. The bottom courses of the wall are made from soft friable sandstone probably from the nearby Sputie Quarry and some of the larger flat blocks have broken apart and moved out of their original position in the wall. The stones are literally being lifted of their foundations.

The stones on either side of the doorway are becoming unstable and one has been propped up from underneath with stones from the beach to help prevent it from collapsing. The dark ashy deposit in the doorway has become exposed and is being washed away and a doorstep has been revealed along the edge of the doorway. The stones at the doorway are barely surviving in-situ, but it is hoped that with the use of sandbags this current state can be preserved, along with any archaeological deposits until the wall is further examined in the spring of 2005.

There is only one part of upstanding wall surviving and it is being attacked from below, where the force of the incoming tide is dislodging stones and sand from lower courses of walling causing instability and, potentially, the imminent collapse of the standing part of the wall. An industrial scale midden composed of ash, burnt coal and clinker approximately 1.5m in height is butted up against the outside face of this part of the wall and it is not known if the midden is contemporary with the use of the building or is it a later deposit of material associated with another period of industry at the site. The midden is eroding out of a large unstable sand dune and stretches approximately 4m along the edge of the eroding dune before it is engulfed by subsiding sand. The full extent of the midden is not known.

It is recommended that the doorway and ashy deposit and the upstanding part of the wall are protected from the further effects from the incoming tides by using sandbags to protect these areas from subsidence and collapse. The site will be monitored on a daily basis until the sandbags are in position and then a weekly monitoring strategy will be undertaken at the site. Progress reports will be sent to Tom Dawson (SCAPE) and Anne Coombs (Historic Scotland).

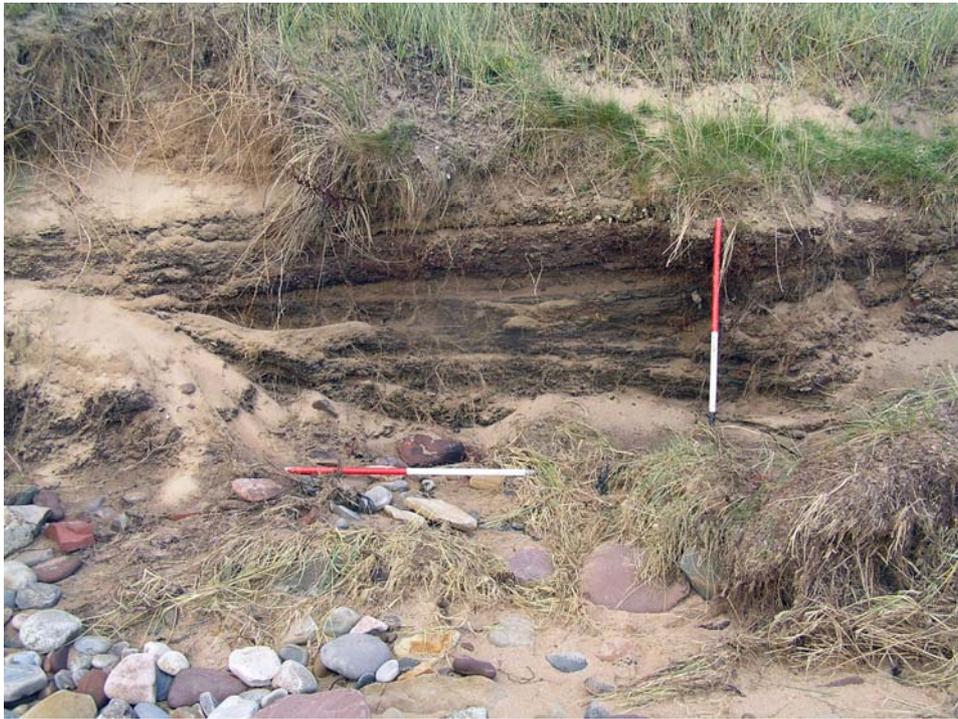
Figure 3 – Industrial midden composed of ash and burnt coal at the site of the old salt pans

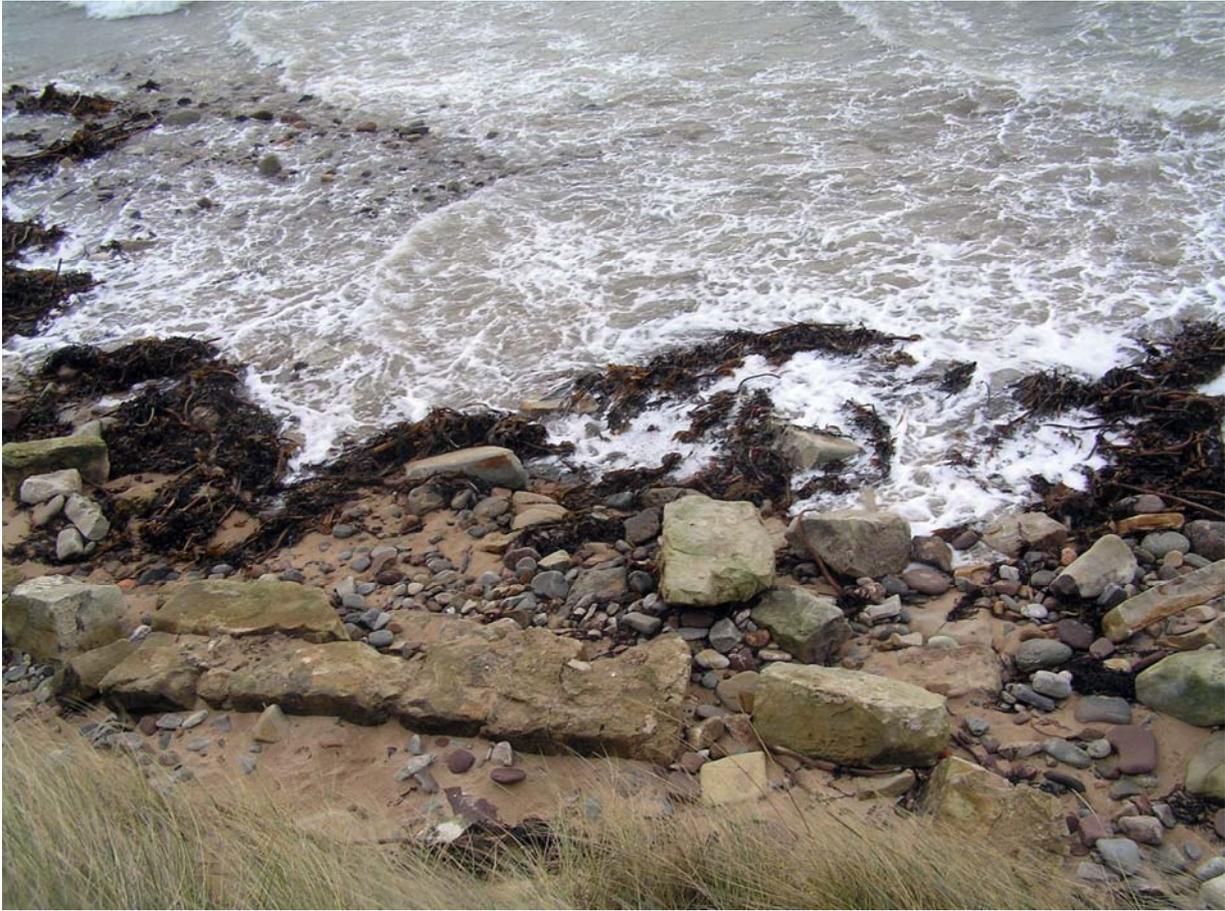
The tides were high and the wall was again under threat. A photographic record was taken as the tide was approaching the wall against a westerly wind. It was observed that the stone and sand bank in front of the wall was beginning to build up again, where it had recently been removed by the combined action of a storm and high tides. It is now obvious that the bank may be removed again at a later date. The loose building blocks that make up the south part of the wall trends down towards the sea, and it is at this point where the tide meets them and washes over them daily. The rest of the wall has suffered from tidal damage and it is suspected that this pattern of destruction will continue during the coming months.

Figure 4 - The wall at Site 1 being battered by the tide, October 2004

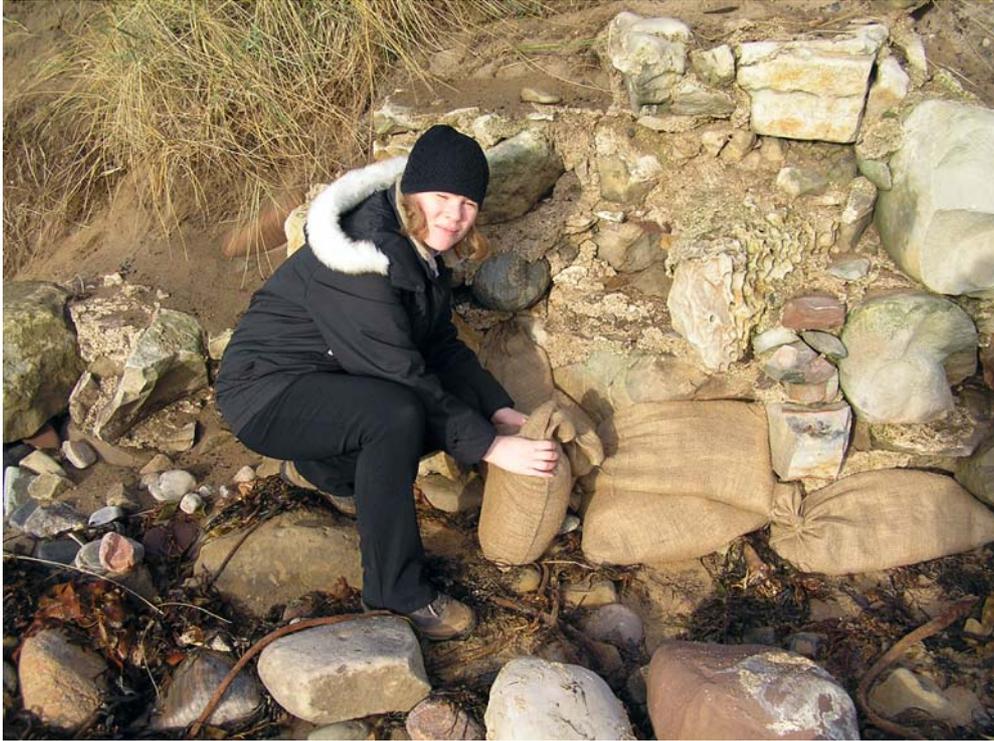
Photo 5 - Sandbags being placed into position against the wall at Site 1

As a precautionary measure sandbags were carefully secured into position up against the only surviving upstanding part of the wall and the adjacent doorway and ashy deposits. These two areas of the wall were specifically targeted as the wall construction is still intact and the remains of the doorway contain archaeological layers that may be later excavated. Stones from the beach were used to secure the tops of some of the sandbags especially along the doorstep and in the crevices of the collapsing wall. It is hoped that this protective action will help to slow down the imminent collapse of the wall until it can be properly recorded in Spring 2005. The sandbags will also help to reduce the erosive effects of wind and rain action from removing mortar from the more secure stones and this should also help to stabilise the parts of the wall targeted.

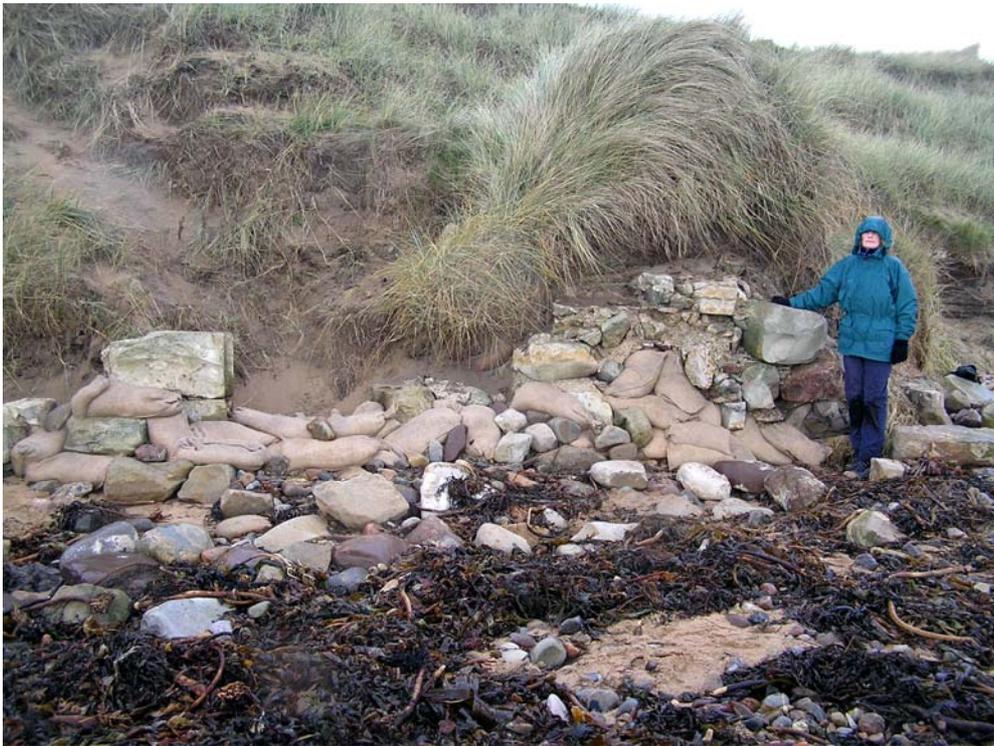
Photo 6 - Sandbags securing the wall at the doorway and the last upstanding portion

It is recommended that more sandbags are required to further secure other parts of the wall. Monitoring will be undertaken twice weekly throughout the winter months. These reports will be sent to Historic Scotland to highlight the imminent threat to the site and provide useful information to assist in any future conservation strategies regarding the site. **Jacqueline E Aitken, 2004**
